Insert Testing

10-32 TYE Pull Test

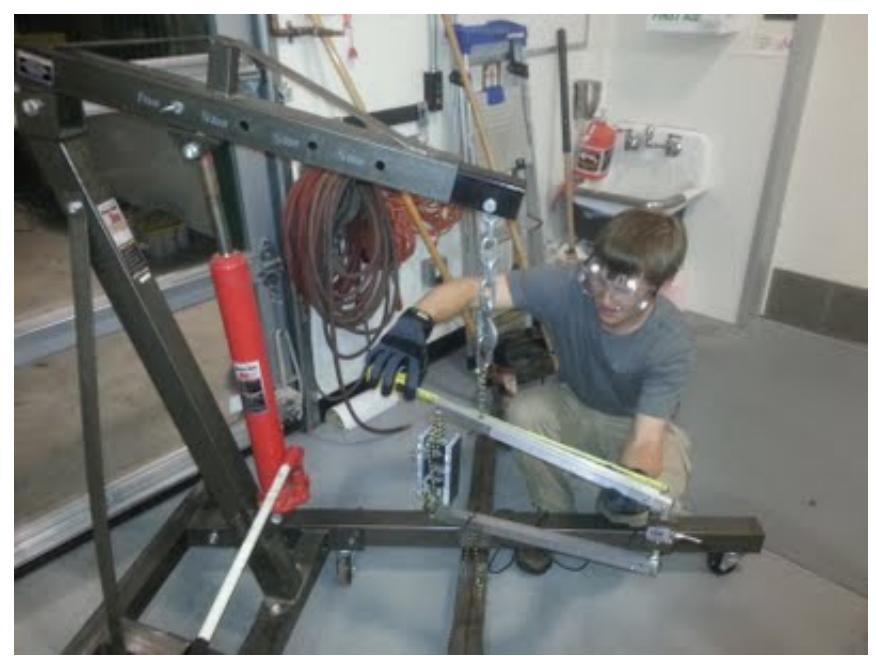
This test used the engine lift, and two aluminum bars as a lever arm so that the force could be measured with the force sensor which has a maximum rated load of only 1kN.

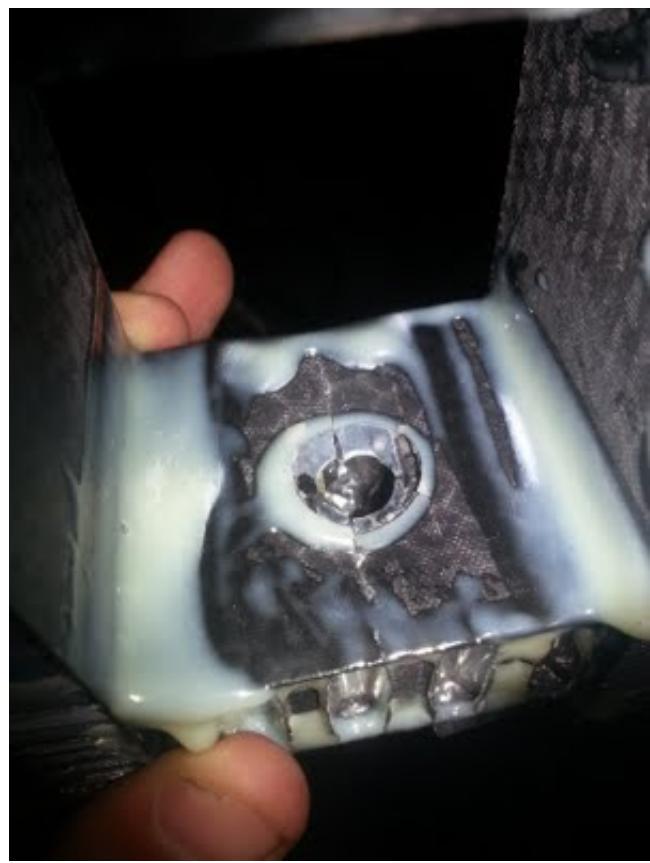
Showing the top of the insert which failed when the glue joint from the insert face to the carbon failed.

The insert failed because the top glue joint failed in shear to the carbon on the top face failed or the edge between the shank and face of the insert failed. To increase the strength of this laminate an insert with a larger face would be required.

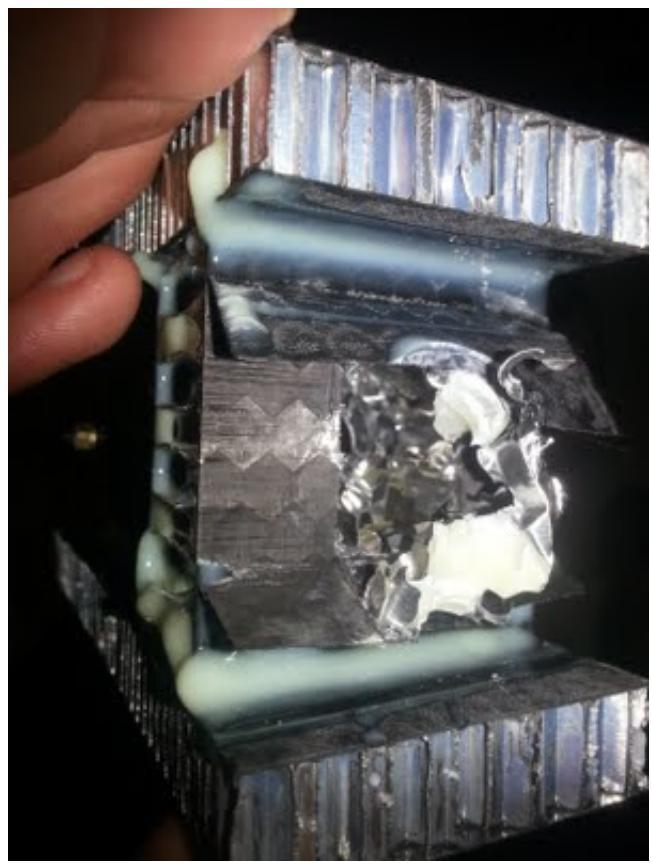
Showing blowout of carbon on bottom of of carbon sandwich panel.

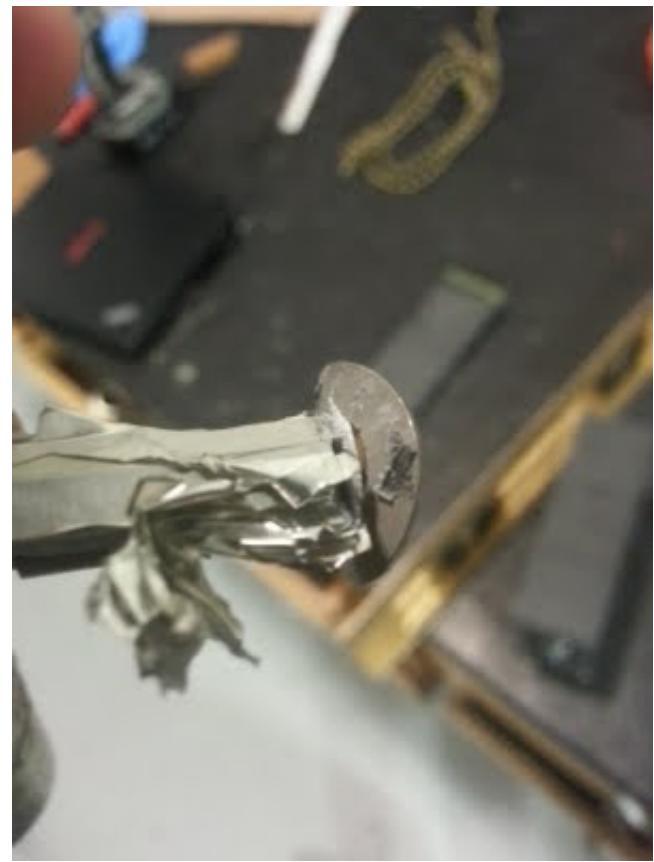
Showing the bent side of the insert that failed and the large crack between the head and shaft of the insert.

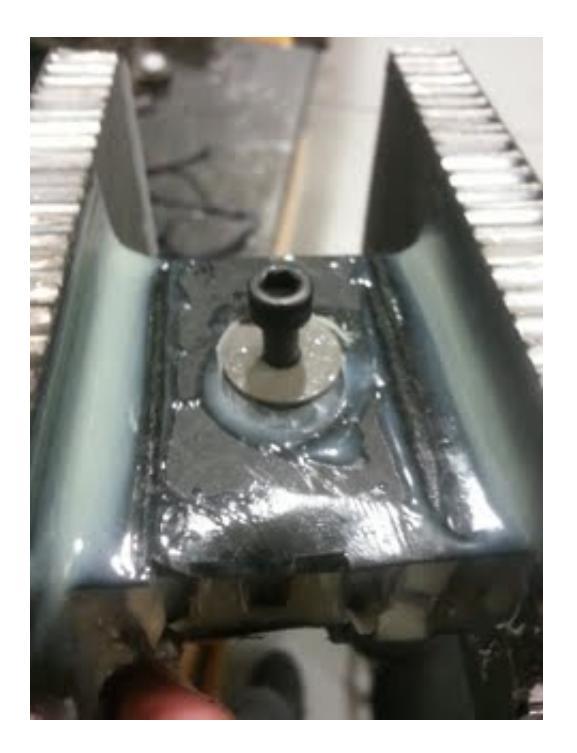
To apply force to the shear bolt two aluminum blocks were placed on either side of the bolt and the assembly was placed in a vice.

Again the failure was in the shear bond to the insert. Unlike the pull test pulling through the actual chassis panel the failure was gradual as pulling the insert through the carbon itself absorbs quite a bit of energy. The take away is that the strength of the insert is entirely <u>dependent on the strength of the glue joint between the face of the insert and the carbon.</u> As the glue joint between the aluminum and the carbon was the element that failed. Increasing the strength would mean using a glue with an increased shear strength or increasing the surface area of the insert head.
